BIOENGINEERING / RIPARIAN HABITAT RESTORATION
SHEEP CREEK ROAD KM 5.5

The Provincial Emergency Program
through the Ministry of Transportation and Highways of the Central Kootenay
District. Contract # 310 LM 7544

Global Forestry Consulting, Nelson, B.C.

July 16, 2001

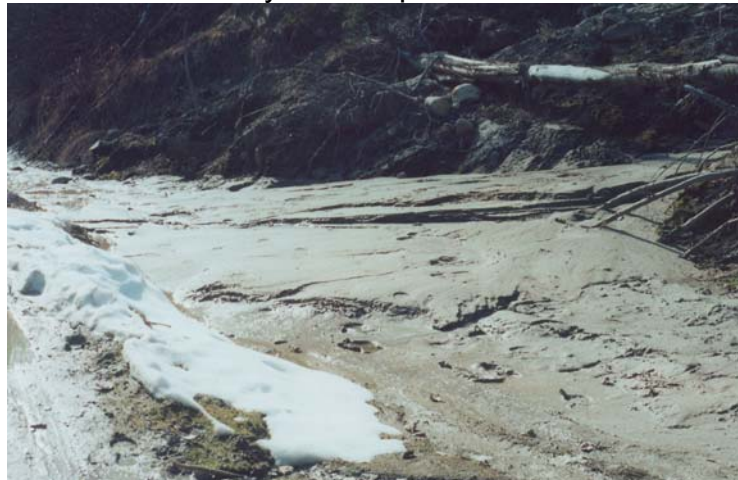
Plate # 1, Mud/earth flow into ditch spring 2001

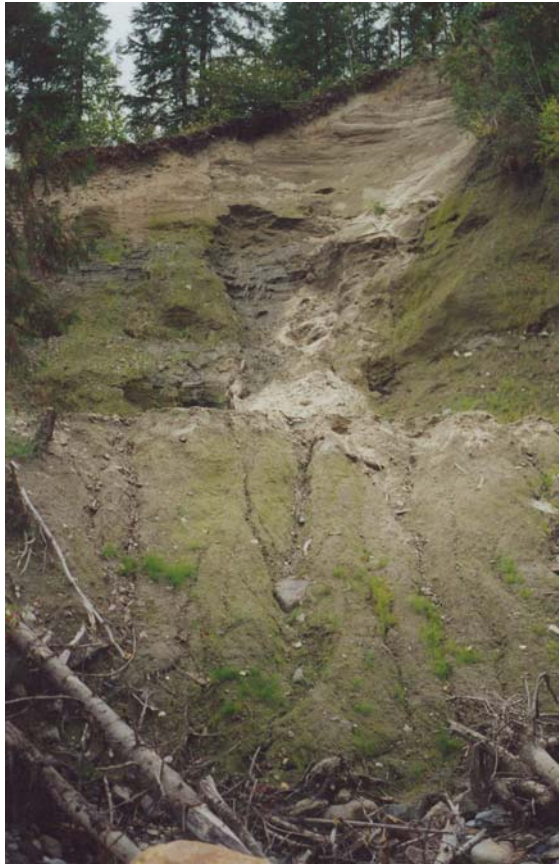
The main failure, designated site 1 in this report, is a debris slide/earth flow, which occurred above the Sheep Creek road and failed/flowed onto the road. Approximate dimensions of the failure are 30 m. wide by 46 m. length by a height at the failure headwall of about 10 metres. Gradients on the slide face range from 80 to 150% and from 30 to 60% on the debris at the toe of the slide. The material is primarily glacio- lacustrine inbedded silt and sand with some clay. In places the materials are varved. (see plate #2). The glaciolacustrine materials are overlain by glaciofluvial sand and gravel. The glaciofluvial materials are dry and well to rapidly drained. The galciolacustrine materials are poorly drained and include extensive areas of seepage. The water table is perched on silt and clay layers in a number of locations. At the site below the road, designated site 2 in this report, is a failing bank where material from the debris slide has been sidecast directly into Sheep Creek. The material on the failing portion of the bank, which is about 31 m long by 10 m wide, has sloughed and ravelled into the creek. The bank gradients are 80 to 100%.

The initial debris slide and earthflow occurred sometime between the fall of 1998 and the spring of 1999 (source MOTH, Creston Office). The cause of the failure is not clear. It may be related to old mining-activities, which altered the drainage patterns on the area upslope. Inspection of the area immediately upslope did not reveal obvious drainage concentration. Removal of toe support in the construction of the road and subsequent ditch cleaning is likely to have been a factor contributing to the failure.

Plate #2; Site 1 and 2, Fall 2000, prior to rehabilitation

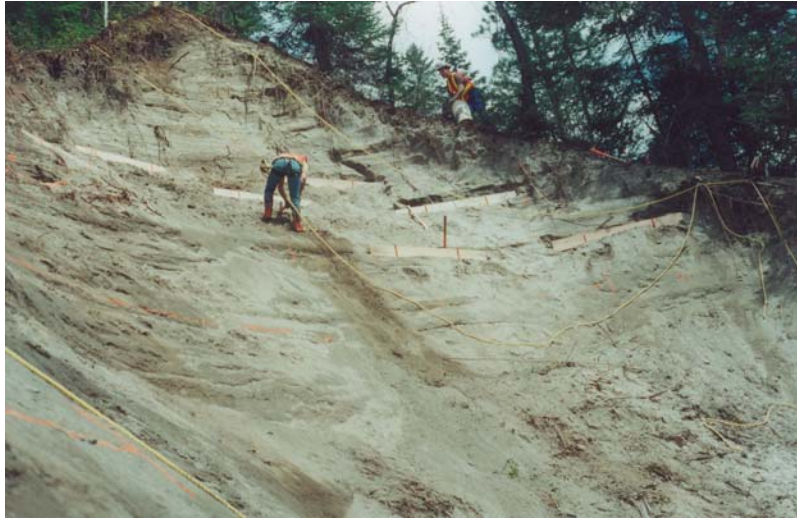
Plate #3; Site 1, Modified brush layers in sandy area

Based on the field visit, site characteristics, and consultation with D. Polster and D. Putt, the following prescription and layout was applied to the site. Modified brush layers (25) were installed in the sandy area at the upper section of the site. These structures should stop the ravelling created by the steepness (100 to 150%) of the sands and gravels and help establish vegetation (see plate #3). The use of contour fascines (see plate #4) and drain fascines in combination with central live pole drains system should help control the excess surface water and seepage on the site (see plate #5). As these structures are partially buried they should be more resistant to the summer drought. These structures will also act as a sediment trap to catch flowing sediment as the woody vegetation sprouts from the fascines. In the area directly above the ditch line the combination of live fascine bundles (25 cm in diam.) placed on a brush layer of 1.0-m. cuttings (see plate #6) should provide support to retain materials and prevent sloughing into the ditch.

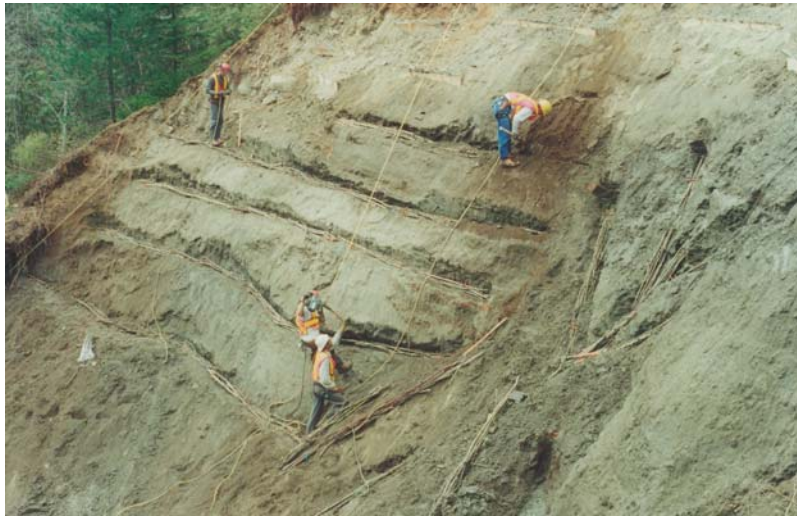
Plate #4; Site #1, Contour fascines and modified brush layers

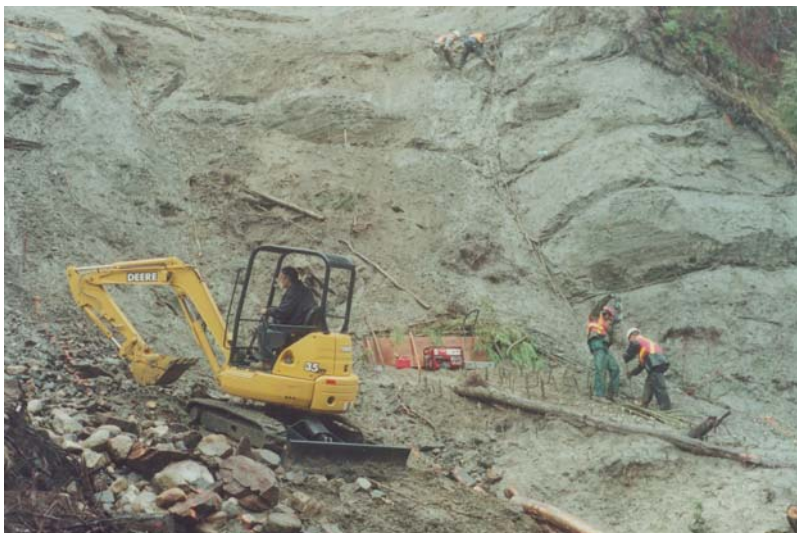
Plate #5; Site #1, Live pole drains/drain fascines and live stakes

Pieces of semi rotten logs were placed on top of the cuttings at the base of the brush layer to provide organic materials and oxygen to enhance root growth. Live stakes (480) were prescribed at the bottom of the site above the road within the debris in the slide runout zone (see plate #5). The root mass produced from the live staking should intertwine together and help stabilize the accumulated materials. Wattle fences were also installed above the live pole drains to retain materials and prevent them from falling and obstructing the drains. Hydro seeding of grasses and legumes mix and container type Sitka mountain alder seedlings were also prescribed to reduce surface erosion and increase the slope stability.

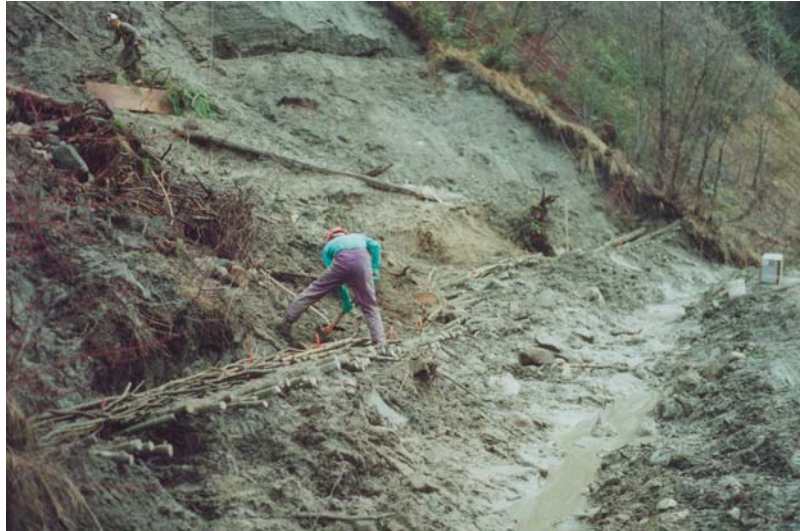
Plate #6; Site #1, Brush layer and contour fascines installations

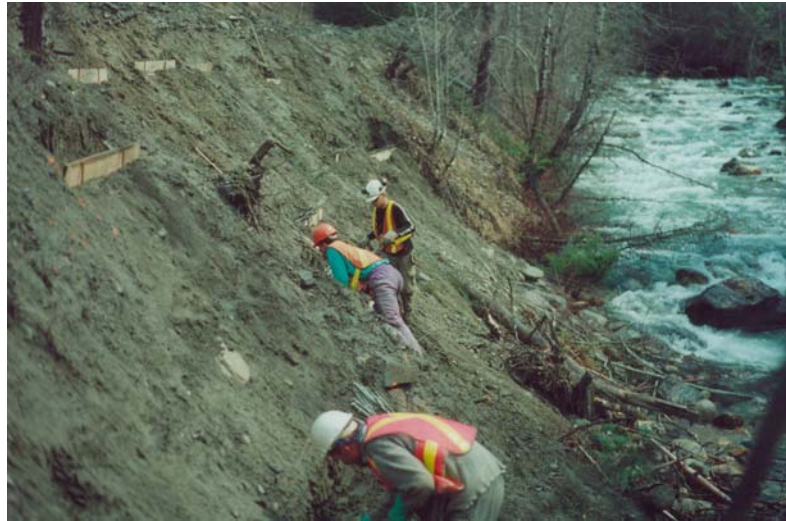
Plate #7; Modified brush layers installations below road

Based on the field visit, site characteristics, and consultation with D. Polster and D. Putt, the following prescription and layout was carried out on the site. The site has a composite of the materials up slope (site 1) which have been sidecast (gravel, sand and silt). The planting directly below the road grade of a combination of live fascine bundles (25 cm in diam.) placed on a brush layer using 0.8-m cuttings should provide support to retain and hold the unstable sidecast material. Modified brush layers (16) were installed in a staggered pattern, between the road and the high water mark directly below the contour fascines/brush layer structure. These modified brush layer structures should stop the ravelling and help establish vegetation (see plate #7). Hydro seeding of grasses and legumes mix, in addition to container type Sitka mountain alder seedlings, was prescribed to reduce surface erosion and increase the slope stability.

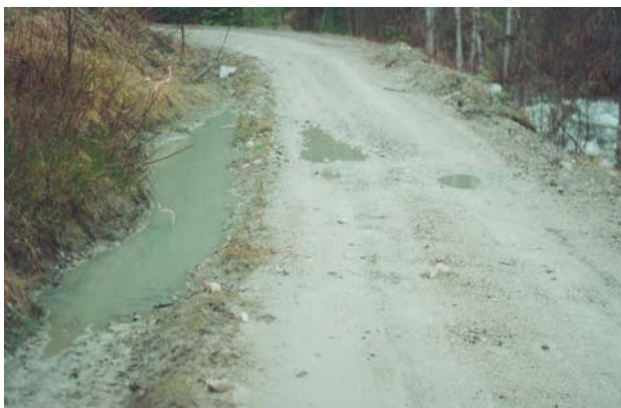
**Plate #8; East of site #1,
Prior to culvert installation**

A mini John Deere excavator was used to conduct minor machine work. The ditch line was cleared of debris and soil and one additional metal culvert (300 mm. In diam.) with plastic flex pipe to carry water down the bank was installed, 21 meters west of an existing metal culvert. The intakes of the existing and new culvert were armoured to prevent bank sloughing and plugging of the culvert (see plate #8,9). As well the excavator was used to excavate the lower portions of the live pole drains system and both the contour fascines/brush layer structures at the toe of site 1 and at the top of site 2.

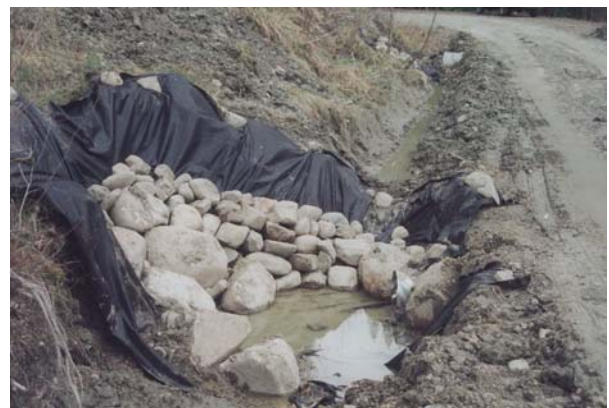
**Plate #9; East of site #1,
Installed culvert and armoring**

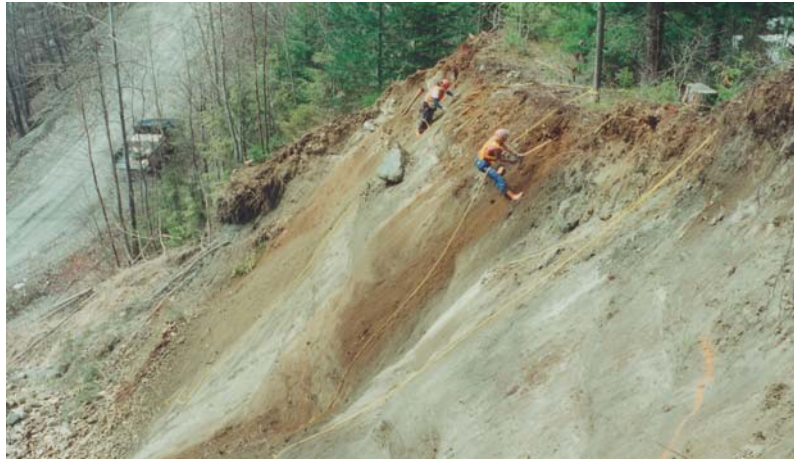
Plate #10; Site1, Site preparation, rock scaling

All wildlife / dangerous trees were assessed by a certified assessor and felled as per W.C.B. regulations. Smaller trees and shrubs were felled above the headwall scarp of site 1 to prevent wind fall which might destabilize the scarp. The scarp was shaved using hand tools to reduce slope angle. Cables were installed in appropriate locations to secure workers for use of climbing harness while installing structures and carrying out on site work. Both sites were rock scaled to remove all loose rock and debris and ensure safe work sites (see plate #10).

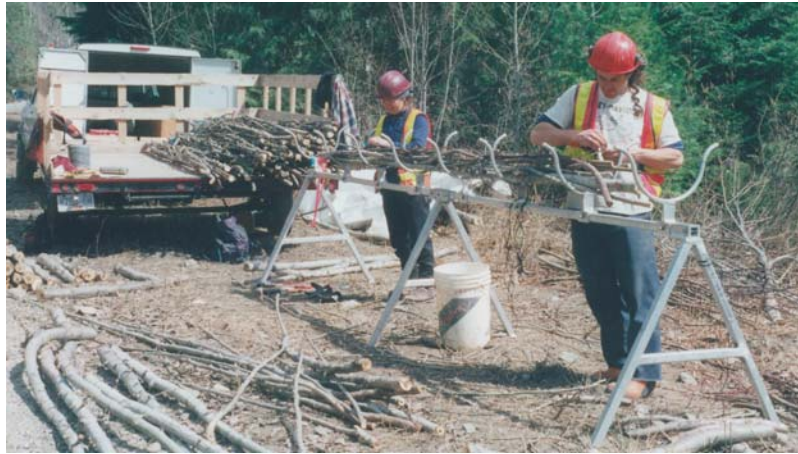
Plate #11; Fascines bundle constructions

A total of 81 fascines / live pole drain bundles were gathered and constructed on site. The dimensions varied from 4 metres in length by 16 to 20 cm in diameter, for the drain fascines and contour fascines, to 4 metres in length by 30 cm in diameter for the live pole drains (see plate # 11, 12). The various fascines and live pole drain bundles were built with an average of 12 to 15 cuttings per bundle, with cuttings varying from 2 to 8 cm in diameter and 1 to 4 metres in length. All fascines and live pole drains were anchored with 15 mm rebar x 0.6 m and 15 mm rebar x 1.3 m with a "T" (6" cross piece) welded at one extremity to insure firm placement. The cuttings gathered for the wattle fences were 19 regular bundles of 12 stems per bundle varying from 2 to 8 cm in diameter and 2 to 4 metres in length. As well, 820 stakes of 0.6 meter, 245 stakes of 0.8 meters, 148 stakes of 1.0 meters and 400 stakes of 1.5 metres were gathered. The stakes varied from 2 to 15 cm in diameter. Each modified brush layers was built using 20 cuttings of 0.6 m and anchored with 2, 15 mm rebar x 1.3 m placed in front of a 1" x 8" board of 6.5' in length. The live materials were transported and stored in Sheep Creek adjacent to about 3km on the Sheep Creek road. They were enclosed within a metal fence supported by rebar to protect the live cuttings from beaver damage. All live materials were stored in water for a period varying from 6 up to 8 days to help promote root initialization. (see plate #13).

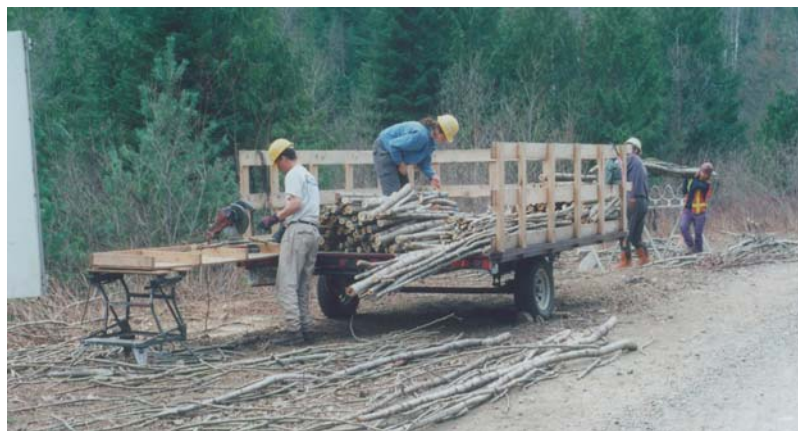
Plate #12; Live stakes preparations

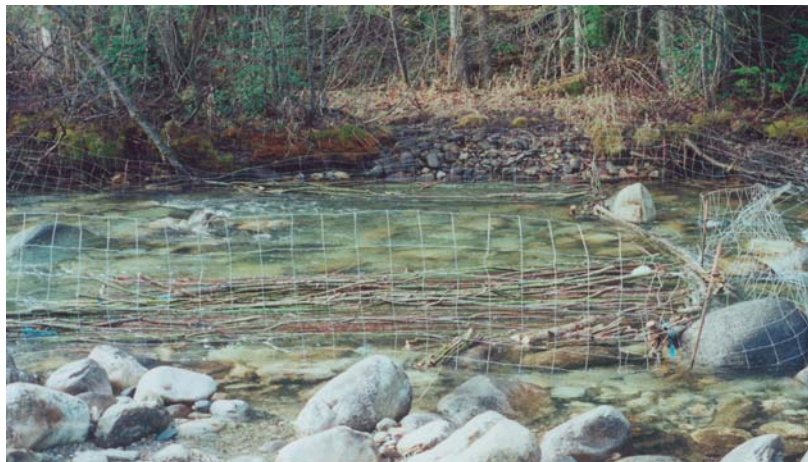
Plate #13; Live materials stored in Sheep Creek
